# TEST REPORT

**Subject:** Mechanical tests: vibration and shock tests of the  
cabinets.

**Identification of sample:** A cabinet designated Free Standing Estap Cabinet 42U,  
with additional loads.

The ESTAP company entrusted to the Laboratoire national de métrologie et d'essai (LNE Trappes – Environmental Testing department) a cabinet designated Free Standing Estap Cabinet 42U (dim.: 2000 x 600 x 600 mm), with additional loads, for the purpose of having it undergo the mechanical tests indicated in the reference documents.

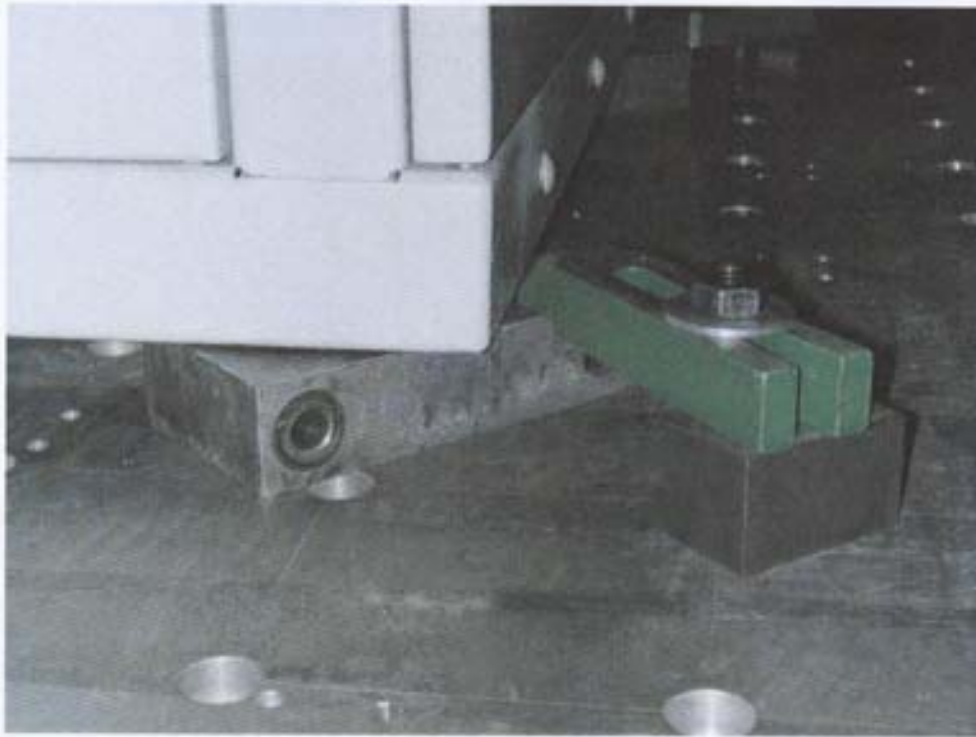
Appendix 2-2

Attachment of the cabinet

The cabinet has jacks that were set down on the vibrating table and held by immobilizing with "Vees"

The testing conditions (including the attachment of the cabinet), the locations of the sensors, and the definitions of the directions of excitation are specified on the view in appendix 2.

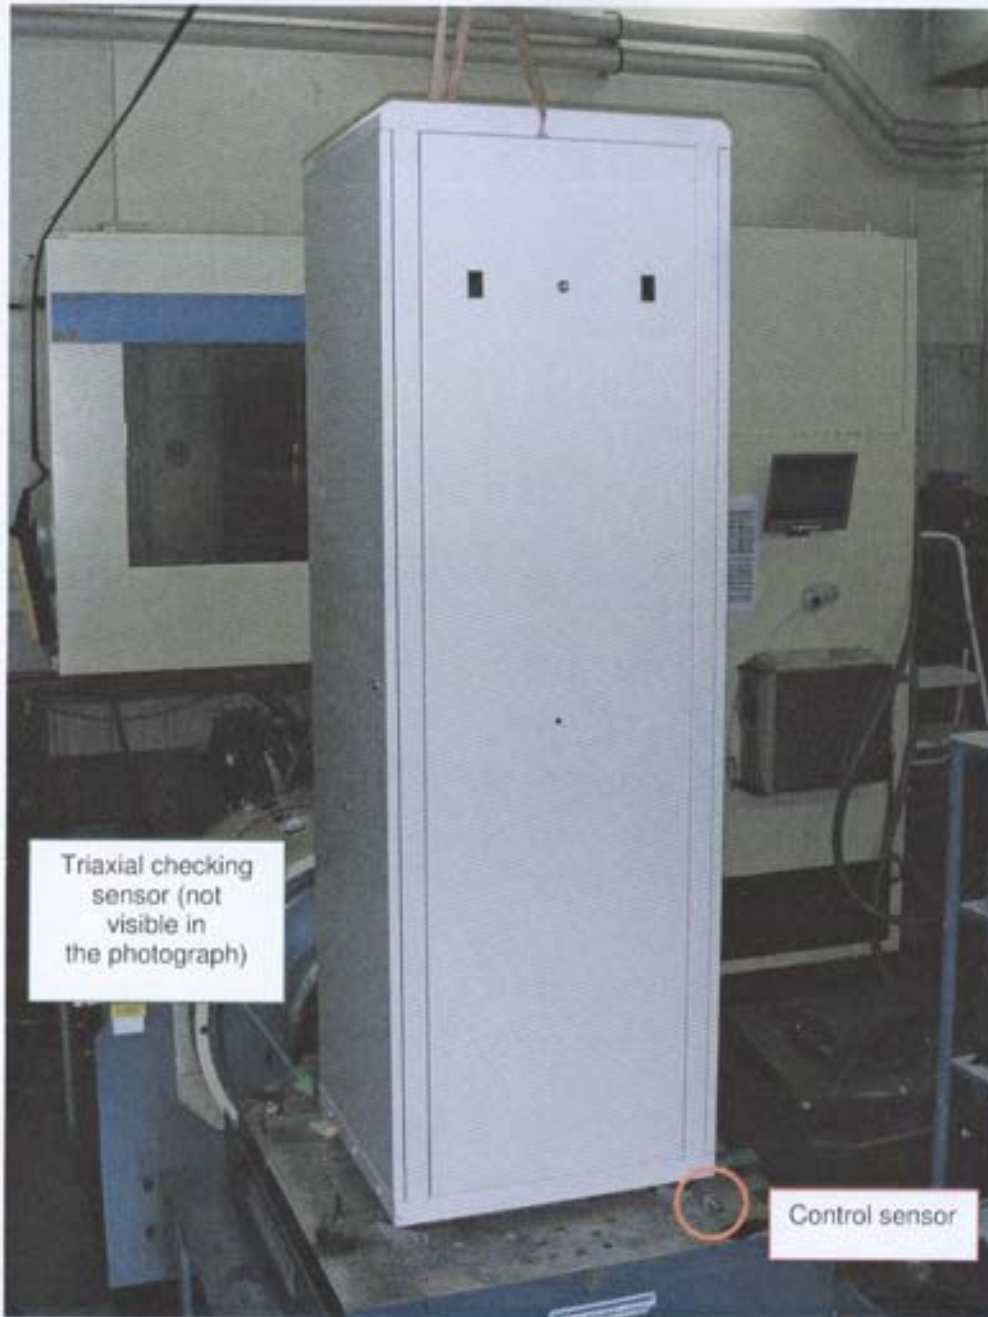
Appendix 2-3

Locations of the control and monitoring sensors

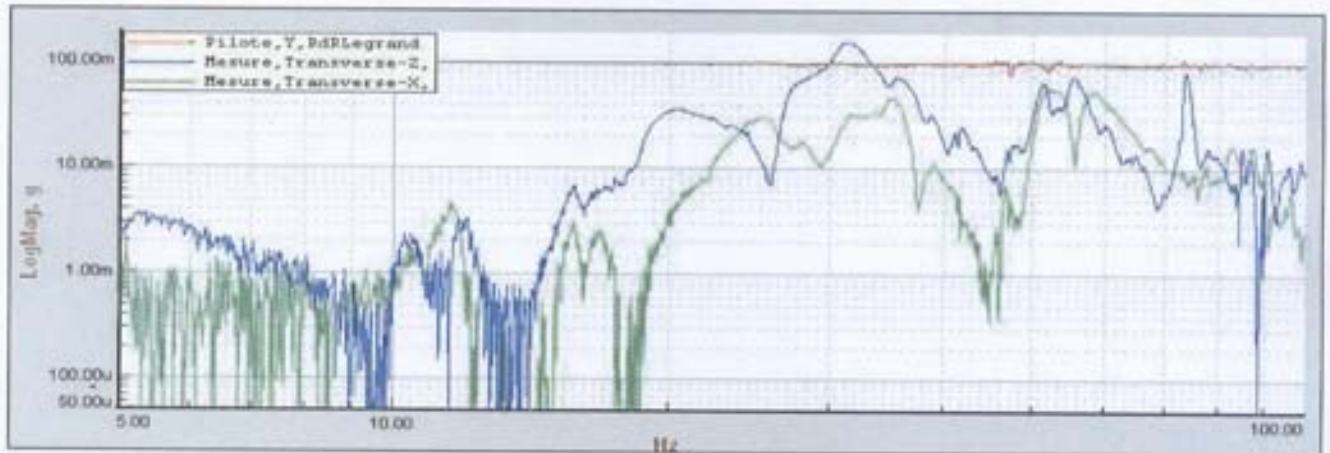
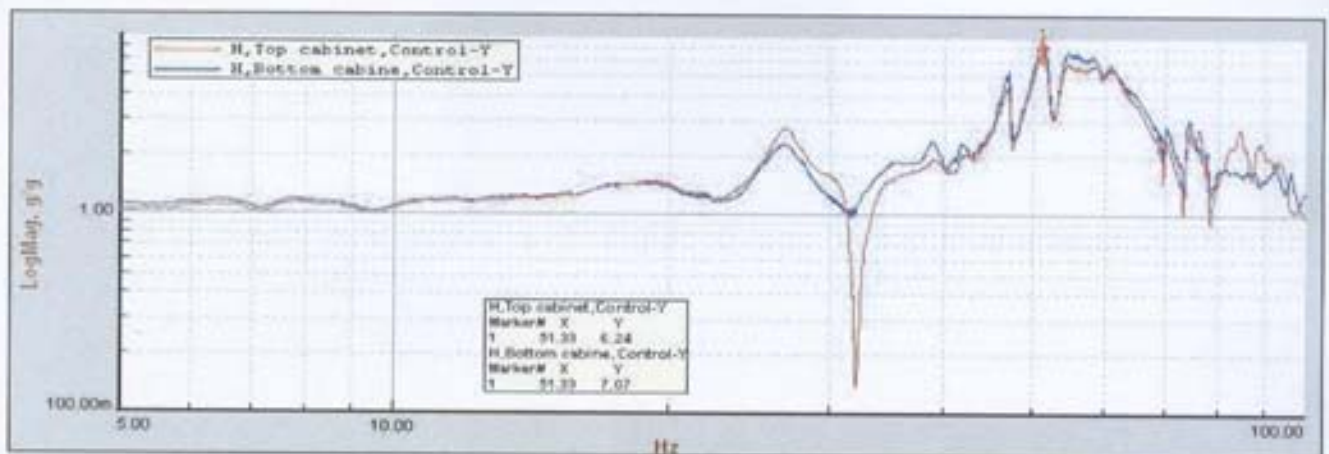
Appendix 3-1

Search for resonance - Y axis (lowering phase)

- Top grap** : Excitation spectrum recorded on the "Pilote" control point superimposed on the "Ref" profile
- Middle graph** : Excitation spectrum recorded on the "Pilote" control point superimposed on the "Transverse-" transverse measurements
- Bottom graph** : "H" amplification factors (Q) recorded on the two auxiliary sensors

Test no.	Designation of the test	Axis of excitation	Duration of test	Remarks	Appendix no.
1	Search for resonance	Y	8 min and 38 sec	<u>Result of the search for resonance:</u> $F_r = 51.3 \text{ Hz}$ ; $Q_{\text{top cab.}} = 6.2$ ; $Q_{\text{bottom cab.}} = 7.1$  <u>Visual inspection:</u> R.A.S.	3-1
2	Hold at resonance		10 min and 40 sec	<u>Restricted sweep around resonance:</u> between 41.0 and 61.6 Hz; rate = 0.11 oct/min or 1 sweep cycle performed  <u>Visual inspection:</u> R.A.S.	3-2
3	Endurance by sweep		2 hours 12 min and 52 sec	<u>Visual inspection:</u> R.A.S.	3-3
4	Shock test*		3 shocks	<u>Visual inspection:</u> R.A.S.	3-4
5	Search for resonance	Z	8 min and 38 sec	<u>Result of the search for resonance:</u> the first $F_r$ is before 5Hz the second: $F_r = 41.2 \text{ Hz}$ ; $Q_{\text{top cab.}} = 4.5$ ; $Q_{\text{bottom cab.}} = 5.5$  <u>Visual inspection:</u> R.A.S.	4-1
6	Hold at resonance		10 min and 38 sec	<u>Restricted sweep around resonance:</u> between 36 and 54 Hz; rate = 0.11 oct/min or 1 sweep cycle performed  <u>Visual inspection:</u> R.A.S.	4-2

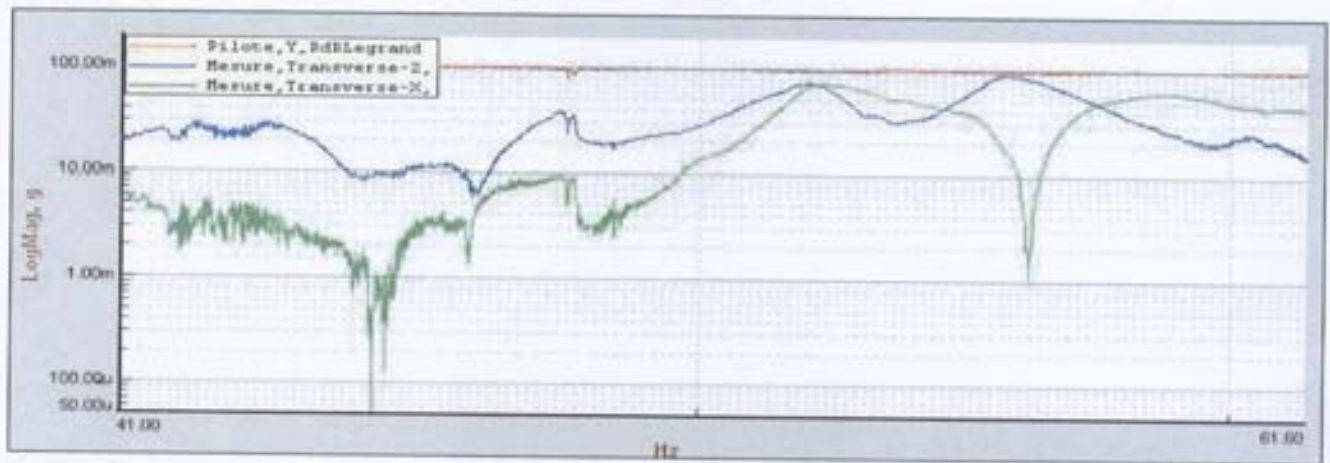
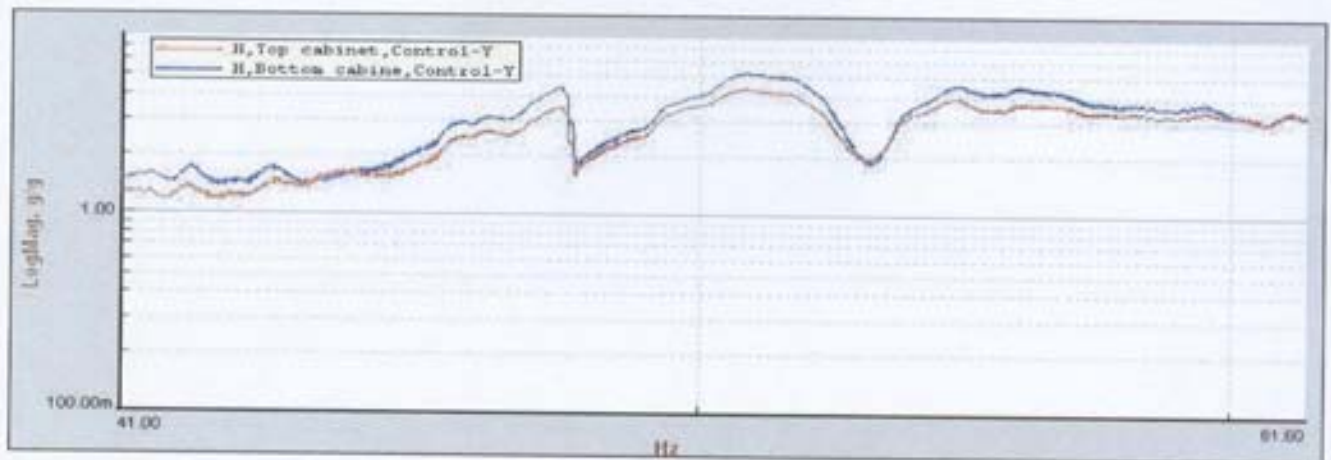
Appendix 3-2

Hold at resonance - Y axis

- Top grap : Excitation spectrum recorded on the "Pilote" control point superimposed on the "Ref" profile
- Middle graph : Excitation spectrum recorded on the "Pilote" control point superimposed on the "Transverse-" transverse measurements
- Bottom graph : "H" amplification factors (Q) recorded on the two auxiliary sensors

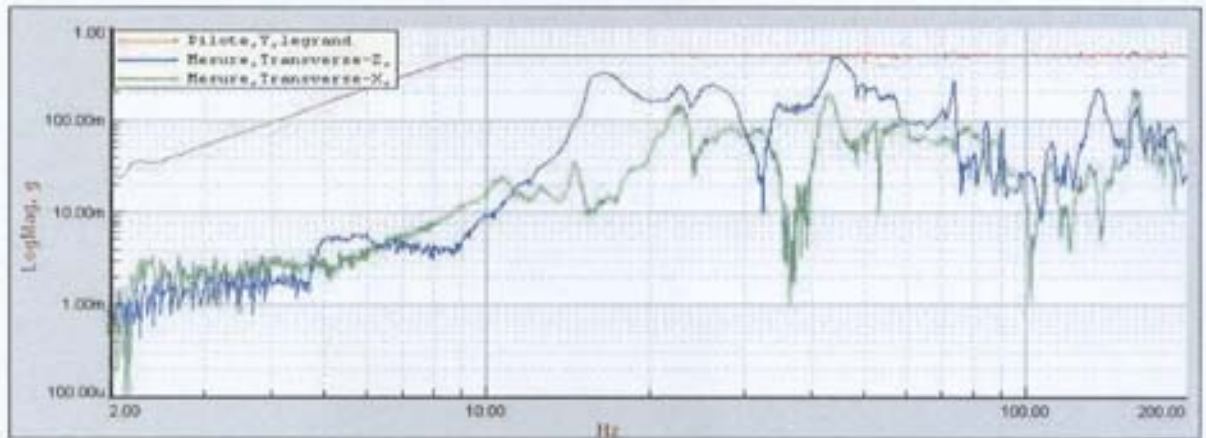
Appendix 3-3

Endurance by sweep - Y axis (last sweep)

- Top grap : Excitation spectrum recorded on the "Pilote" control point superimposed on the "Ref" profile
- Middle graph : Excitation spectrum recorded on the "Pilote" control point superimposed on the "Transverse-" transverse measurements
- Bottom graph : "H" amplification factors (Q) recorded on the two auxiliary sensors

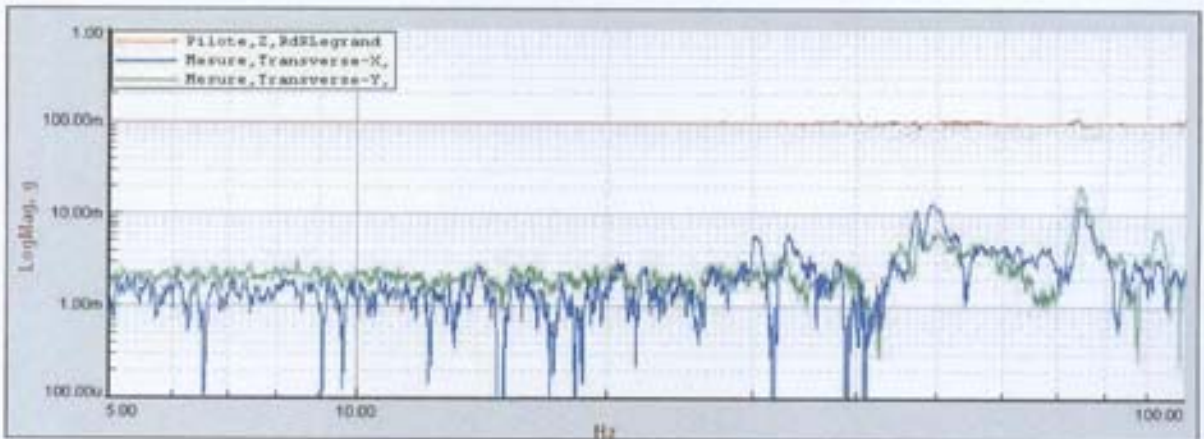
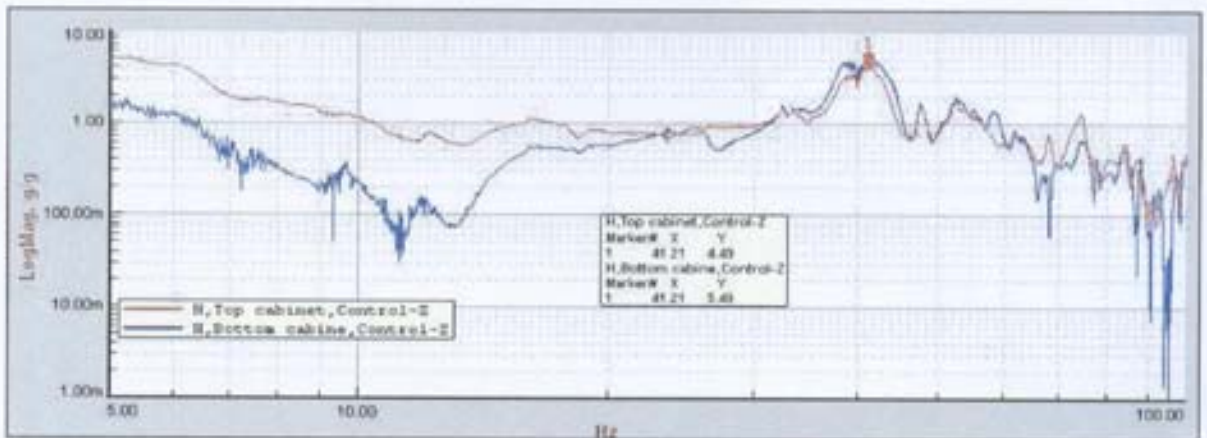
Appendix 4-1

Search for resonance - Z axis (lowering phase)

- Top grap : Excitation spectrum recorded on the "Pilote" control point superimposed on the "Ref" profile
- Middle graph : Excitation spectrum recorded on the "Pilote" control point superimposed on the "Transverse-" transverse measurements
- Bottom graph : "H" amplification factors (Q) recorded on the two auxiliary sensors

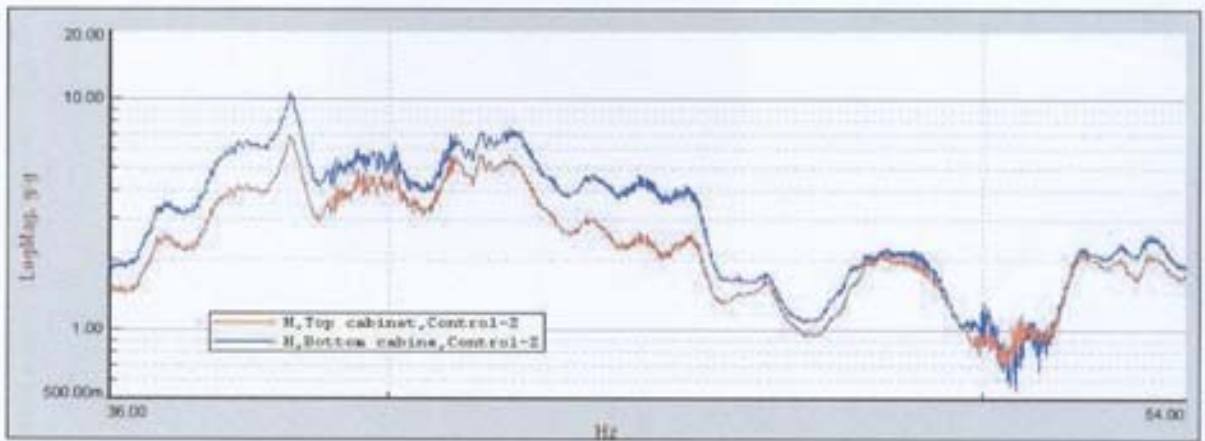
Appendix 4-2

Hold at resonance - Z axis

- Top grap : Excitation spectrum recorded on the "Pilote" control point superimposed on the "Ref" profile
- Middle graph : Excitation spectrum recorded on the "Pilote" control point superimposed on the "Transverse-" transverse measurements
- Bottom graph : "H" amplification factors (Q) recorded on the two auxiliary sensors

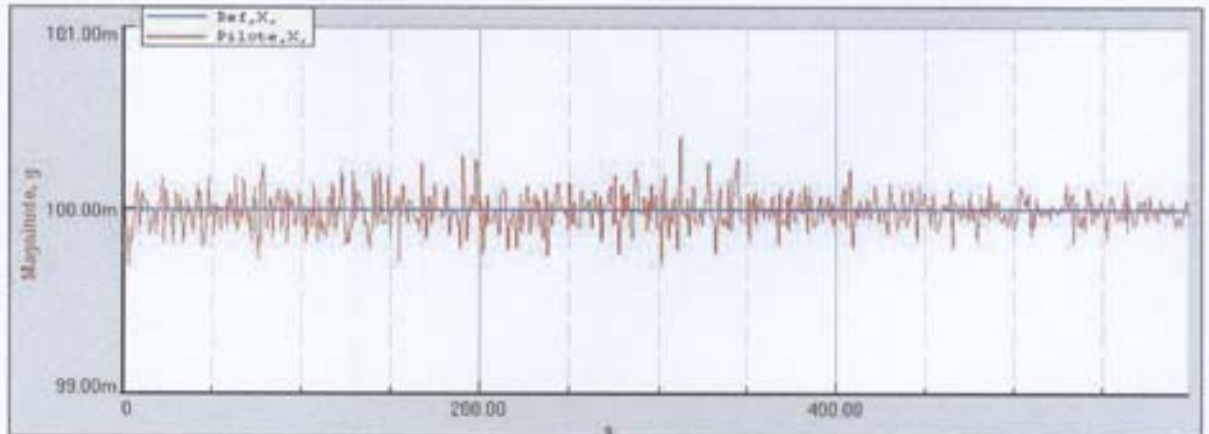
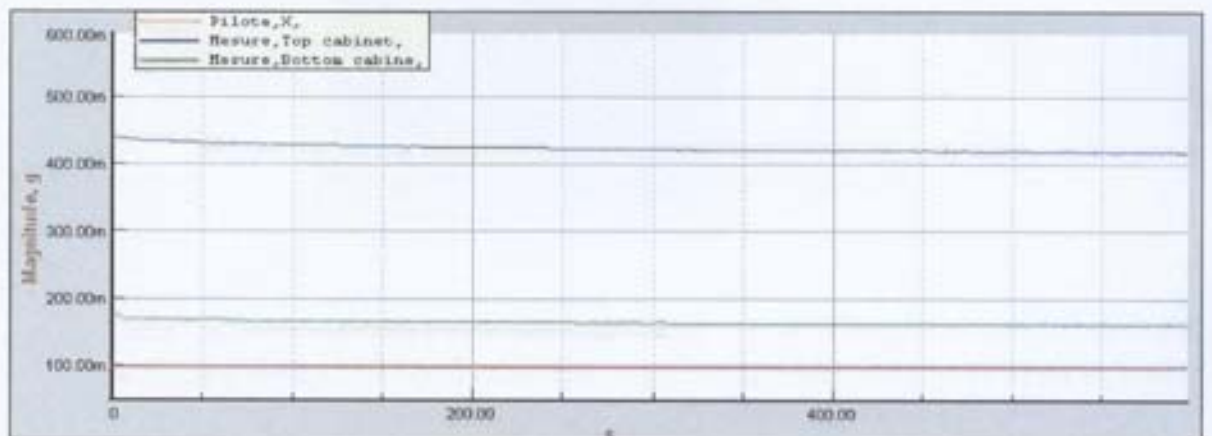
Appendix 5-2

Hold at resonance - X axis

- Top graph : Excitation spectrum recorded on the "Pilote" control point superimposed on the "Ref" profile
- Middle graph : Excitation spectrum recorded on the "Pilote" control point superimposed on the "Transverse-" transverse measurements
- Bottom graph : Accelerometric measurements recorded on the 2 auxiliary sensors

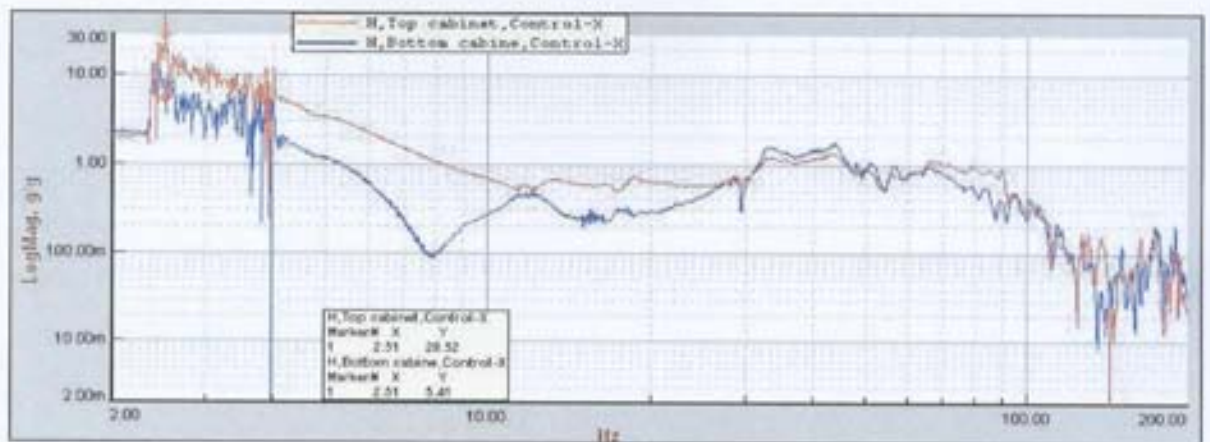
Appendix 5-3

Endurance by sweep - X axis (last sweep)

- Top grap : Excitation spectrum recorded on the "Pilote" control point superimposed on the "Ref" profile
- Middle graph : Excitation spectrum recorded on the "Pilote" control point superimposed on the "Transverse-" transverse measurements
- Bottom graph : "H" amplification factors (Q) recorded on the two auxiliary sensors

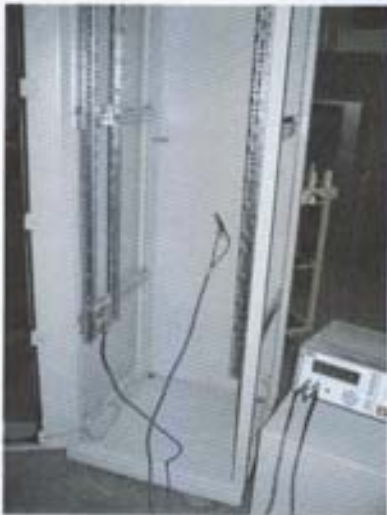
Appendix 6-1

Conditions of ground continuity measurements \*

ground continuity between the chassis and the rear panel

injection of 12 VDC at 25 A (open circuit) for one minute between different points on the structure of the cabinet.

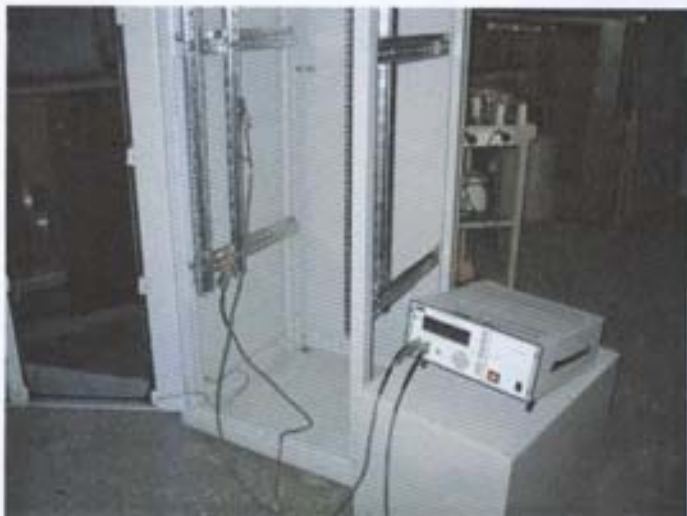
ground continuity between the chassis and the side panel

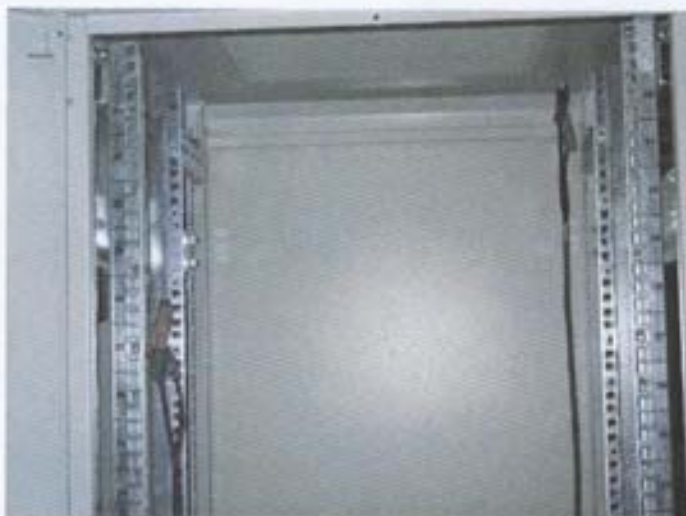
ground continuity between the chassis and the top surface

Test no.	Designation of the test	Axis of excitation	Duration of test	Remarks	Appendix no.
7	Endurance by sweep		2 hours 12 min and 52 sec	<u>Visual inspection</u> ; R.A.S.	4-3
8	Search for resonance	Y	8 min and 38 sec	<u>Result of the search for resonance</u> : F <sub>r</sub> is before 5 Hz  <u>Visual inspection</u> : R.A.S.	5-1
9	Hold at resonance		10 min	<u>Hold at fixed frequency of 5 Hz</u>  <u>Visual inspection</u> : R.A.S.	5-2
10	Endurance by sweep		2 hours 12 min and 52 sec	<u>Visual inspection</u> : R.A.S.	5-3
11	Tests of continuity of ground*	-	-	<u>Tests of continuity of ground*</u> :  Measurements satisfactory → values < 100 mΩ  - between the chassis and the side panel = 3.72 mΩ - between the chassis and the hinged rear panel = 4.01 mΩ - between the chassis and the front door = 3.04 mΩ - between the chassis and the top surface = 2.22 mΩ - between the right and left parts of the chassis = 1.96 mΩ	6

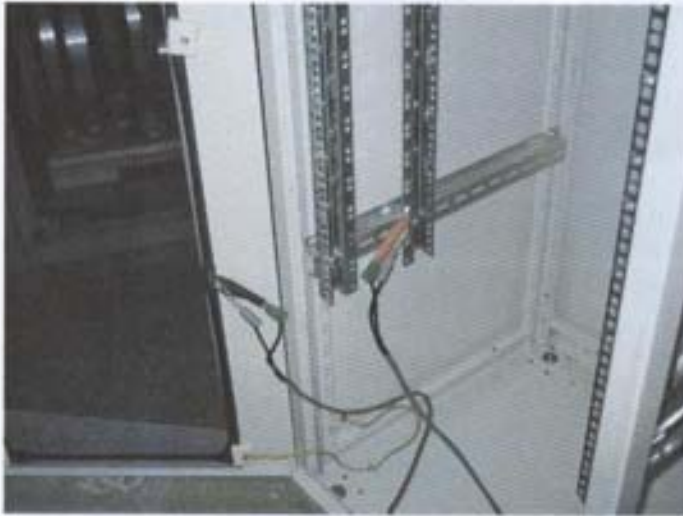
Appendix 6-2

Conditions of ground continuity measurements \* (concluded)

ground continuity between the chassis and the front door

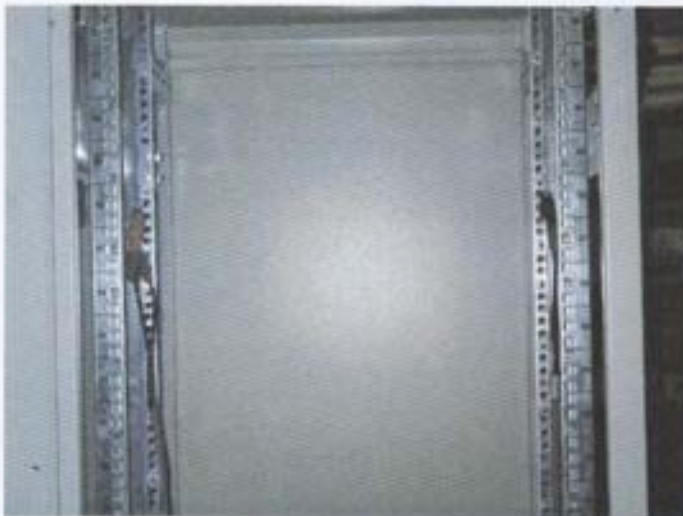
ground continuity between the right and left uprights
